DEPARTMENT OF TRANSPORTATION**DIVISION OF ENGINEERING SERVICES**

Contract #: 04-0120F4Cty: SF/ALA Rte: 80 PM: 13.2/13.9File #: 69.28**WELDING INSPECTION REPORT****Resident Engineer:**Siegenthaler, Peter**Address:** 333 Burma Road**City:** Oakland, CA 94607**Report No:** WIR-022424**Date Inspected:** 06-Apr-2011**Project Name:** SAS Superstructure**OSM Arrival Time:** 700**Prime Contractor:** American Bridge/Fluor Enterprises, a JV**OSM Departure Time:** 1900**Contractor:** Zhenhua Port Machinery Company, Ltd (ZPMC), Changxing Island **Location:** Shanghai, China**CWI Name:** Mr. Liu hua jie**CWI Present:** Yes No**Inspected CWI report:** Yes No N/A**Rod Oven in Use:** Yes No N/A**Electrode to specification:** Yes No N/A**Weld Procedures Followed:** Yes No N/A**Qualified Welders:** Yes No N/A**Verified Joint Fit-up:** Yes No N/A**Approved Drawings:** Yes No N/A**Approved WPS:** Yes No N/A**Delayed / Cancelled:** Yes No N/A**Bridge No:** 34-0006**Component:** Orthotropic Box Girder(OBG)**Summary of Items Observed:**

Segment:13AW

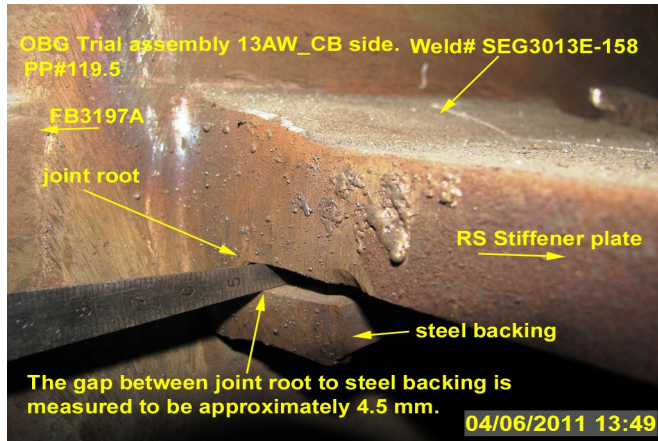
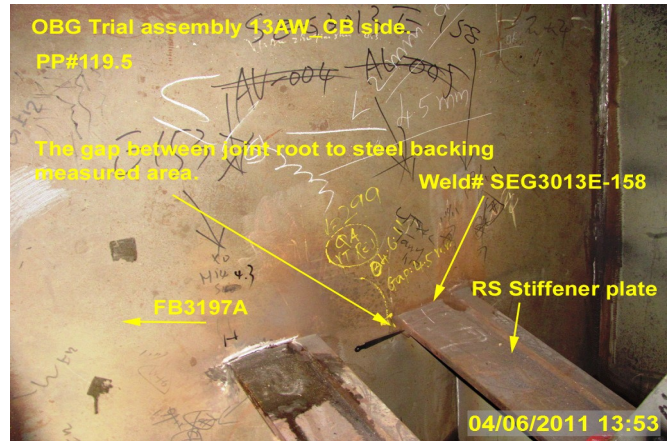
ZPMC personnel installing the Saddle beam support by using crane at PP 118~119.5 Counter weight side. See attached photos for further information.
